**KOOTENAI DEVELOPMENT IMPOUNDMENT DAM
NOVEMBER 9TH, 2007 ROUTINE INSPECTION REPORT**

BILLMAYER & HAFFERMAN ENGINEERING INC.

February 22, 2008

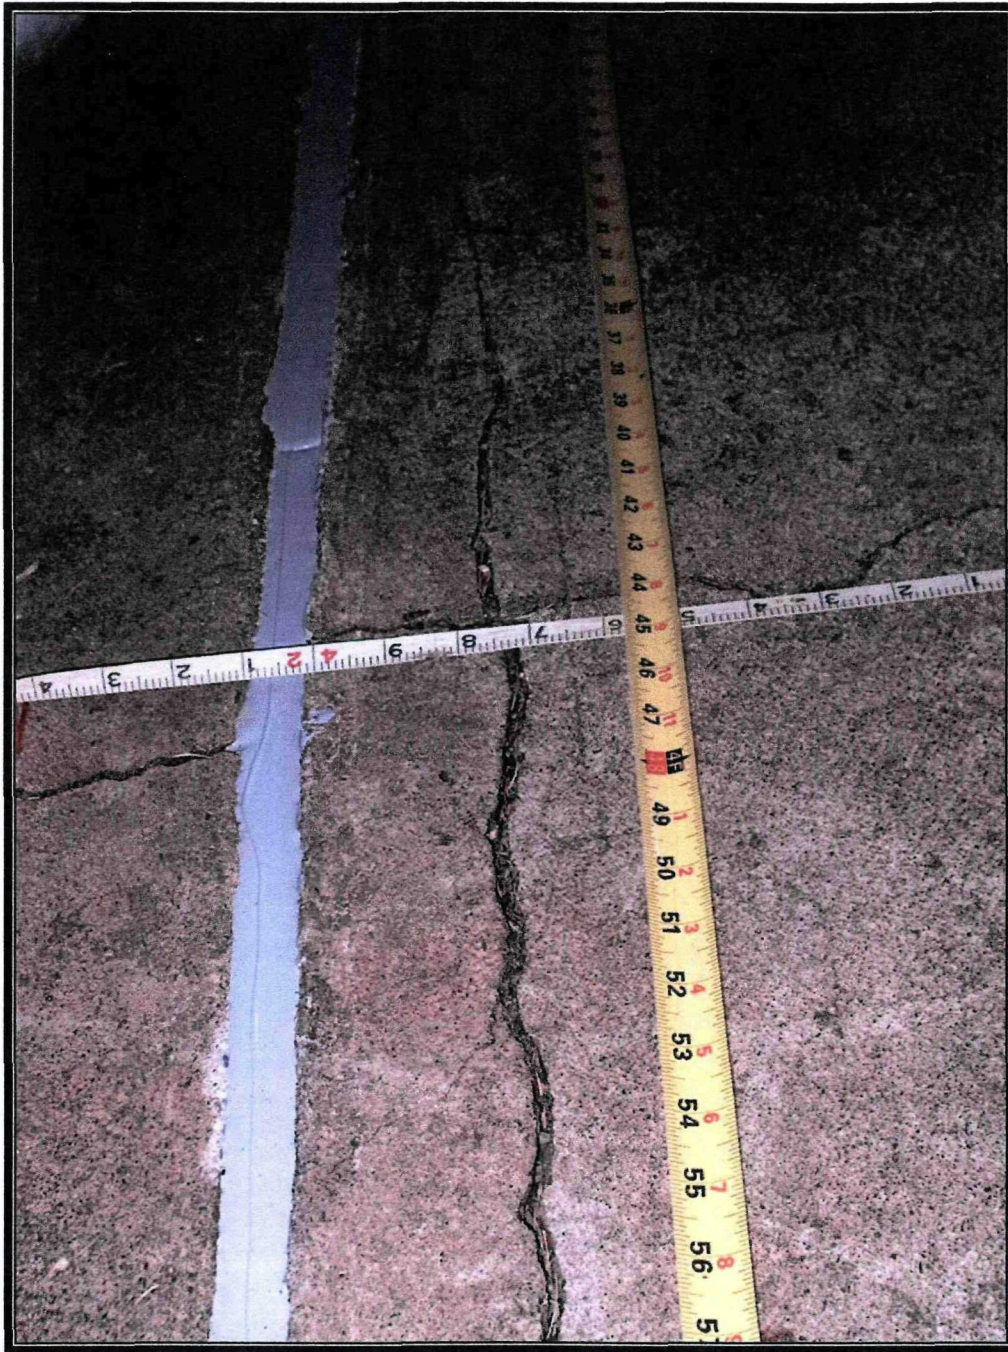
Figure 1 First Transverse Joint

The transverse expansion cracks throughout the box culvert have been cleaned and re-caulked by Chapman Construction. A photograph of the first transverse joints located 42 ft. from the entrance is shown in Figure 1 below;

G.4. Expansion Joints: The expansion joint material in the transverse expansion joints was scraped out, cleaned well, and re-caulked with a SikaFlex® concrete crack repair caulk. The material missing from the vertical joints on the right side, as shown in photograph E3-21 of the May 23, 2007 Annual Owners Inspection Report were also cleaned and replaced and re-caulked. This project is complete.

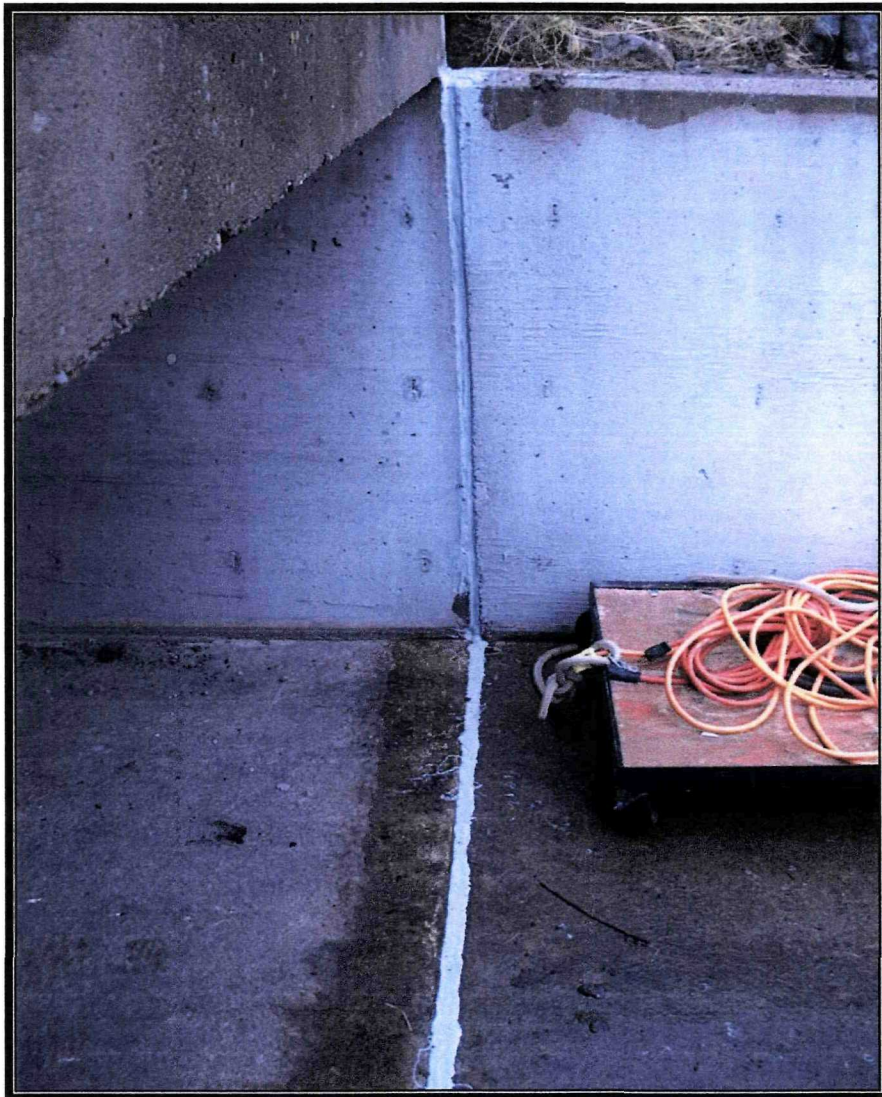
Figure 2 Transverse Joint at Start of Open Chute Spillway

The open chute spillway was inspected from the outlet of the box culvert to the top of the steep section of the chute. The sidewall load cracks and the pieces of the wall top that had spalled or cracked off are currently being repaired by Chapman Construction. The means and methods used to complete the repairs were discussed with Chapman Construction. All of the side wall load cracks and the stress cracks are being ground out with a diamond tipped blade on a hand held grinder. The cracks are being cleaned and then filled with a Sika Flex™ caulk. Each of the transverse construction joints are also being cleaned out and filled with the Sika Flex™ caulk. A photograph of the first transverse joint at the outlet from the box culvert is shown in Figure 2 below;

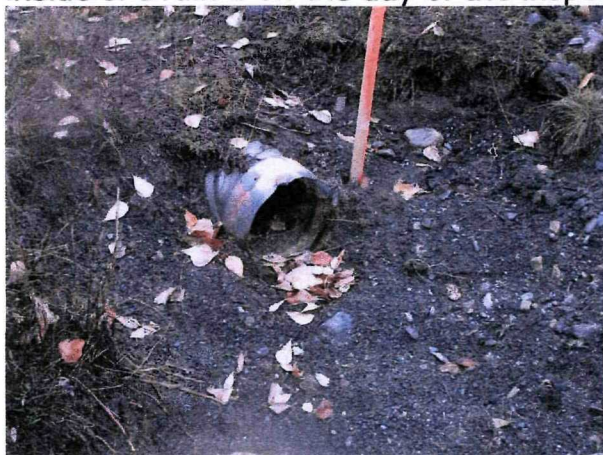
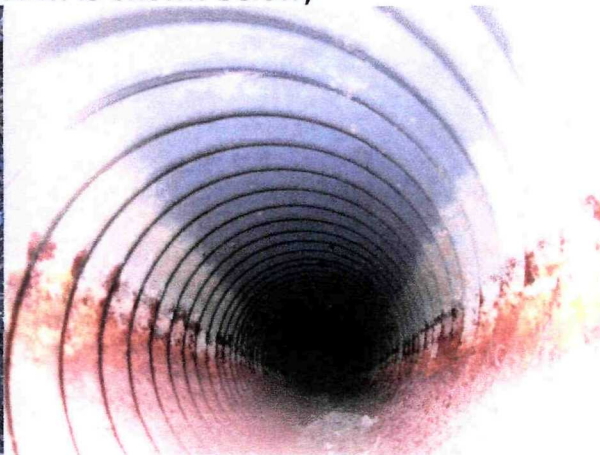
Figure 3: Drain 1 outside and inside

Drain 1: A 12-inch Corrugated Metal Pipe (CMP) in the left groin. The drain was dry. Brush and weeds have been cleaned near each outlet. A photograph of outside and inside of Drain 1 on the day of the inspection is shown below;

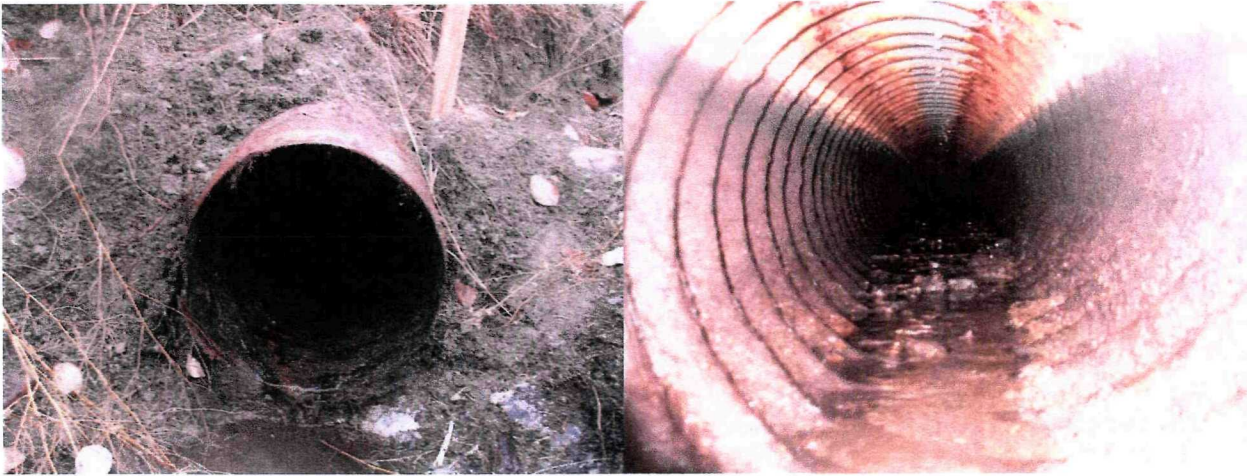
Figure 4: Drain 2 outside and inside

Drain 2: A 12-inch CMP in the left groin. The drain has a small amount of running water and was moist inside. The flow was estimated to be between 3 gpm and 5 gpm. Brush and weeds were cleaned near the outlet. A photograph of the outside and inside of the pipe is shown in Figure 4 below.

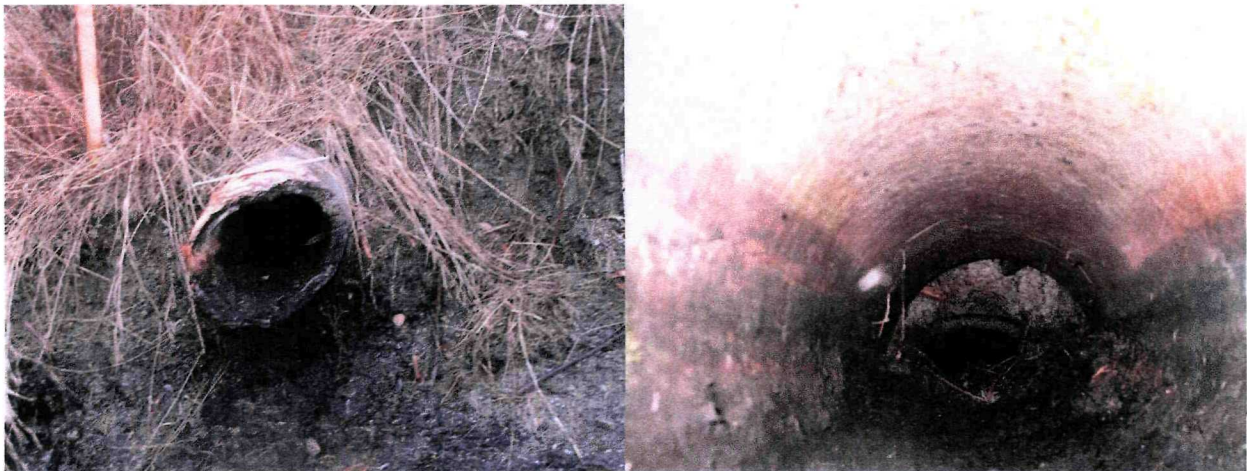
Figure 5: Drain 3 outside and inside

Drain 3: Is an 8-inch concrete pipe near the left groin. The drain was not running water but there was water on the outside and at the toe of the drain. Brush and weeds were cleaned near the outlet. A photograph of the outside and inside of the drain is shown in Figure 5 below. There appears to be a blockage or displacement in the pipe as shown.

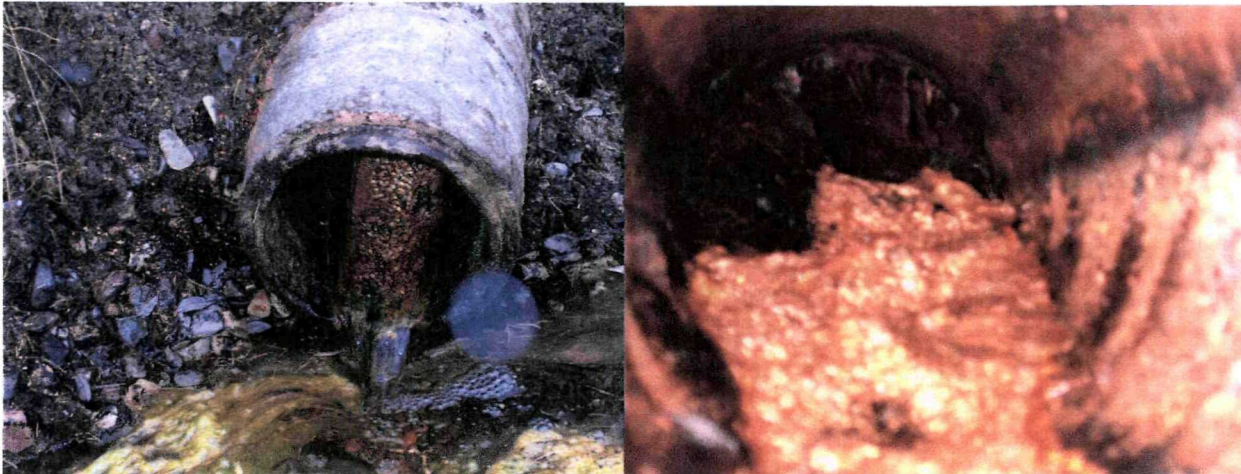
Figure 6: Drain 4 outside and inside

Drain 4: An 8-inch concrete pipe, with the end sticking out, in the left side, approximately 50 feet from left groin. The drain was flowing water that was estimated at approximately 3 gpm to 5 gpm. A photograph of the outside and inside of the drain is shown in Figure 6 below;

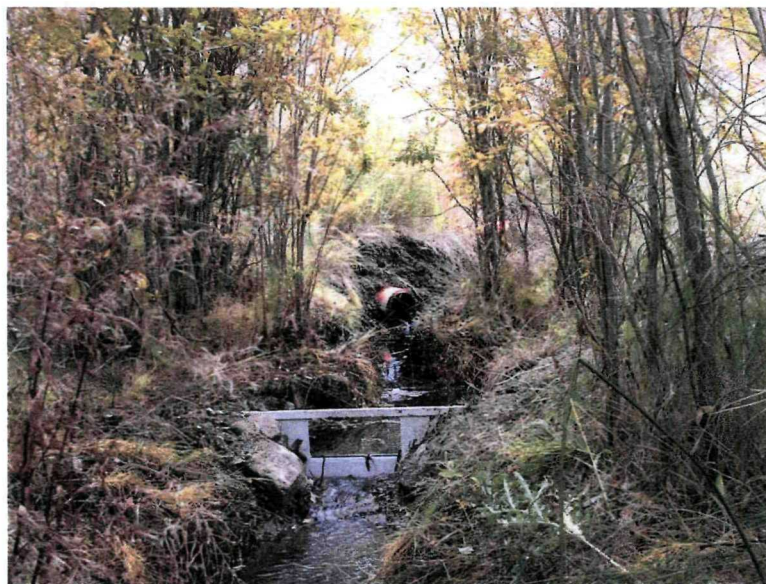
Figure 7: Weir below drains 1,2,3,and 4

A 1-ft. Rectangular-notch weir was set in the drain channel below drain 1, 2, 3, and 4. The 1 foot rectangular weir read 0.5 inches 2 hours after being set which is equal to 12.6 gpm. A photograph of the weir immediately after it was set is shown in Figure 7 below:

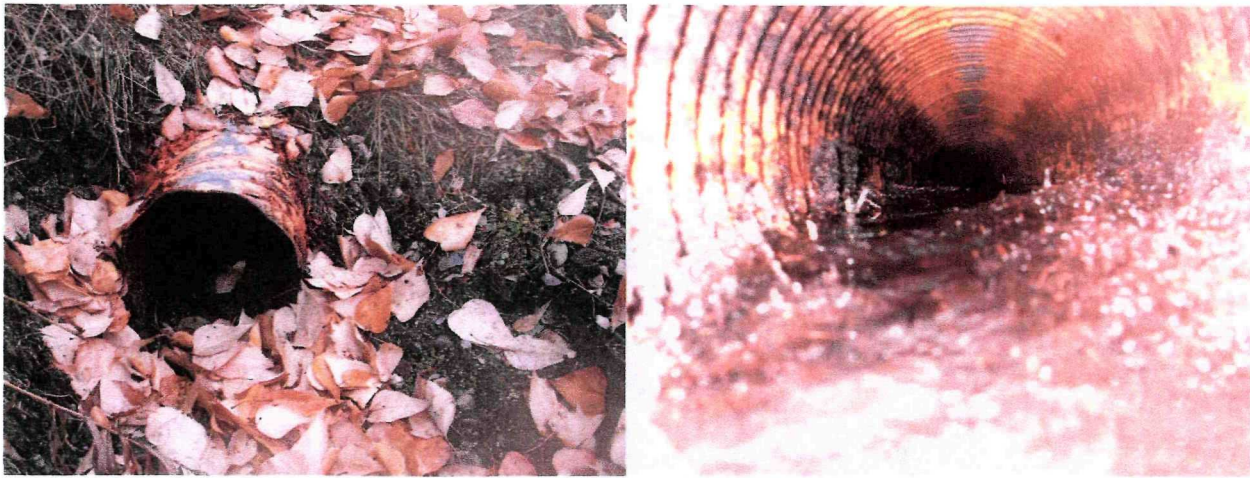
Figure 8: Drain #5 outside and inside

Drain 5: Drain 5 is a 12-inch CMP pipe projecting from the face of the embankment. The drain is near the center of the embankment. The pipe was running water and the depth of the water was measured at 0.18 feet deep. A V-notch weir was set below the pipe. A photograph of the pipe is shown in Figure 8 below. A photograph of the weir is shown in Figure 9 below.

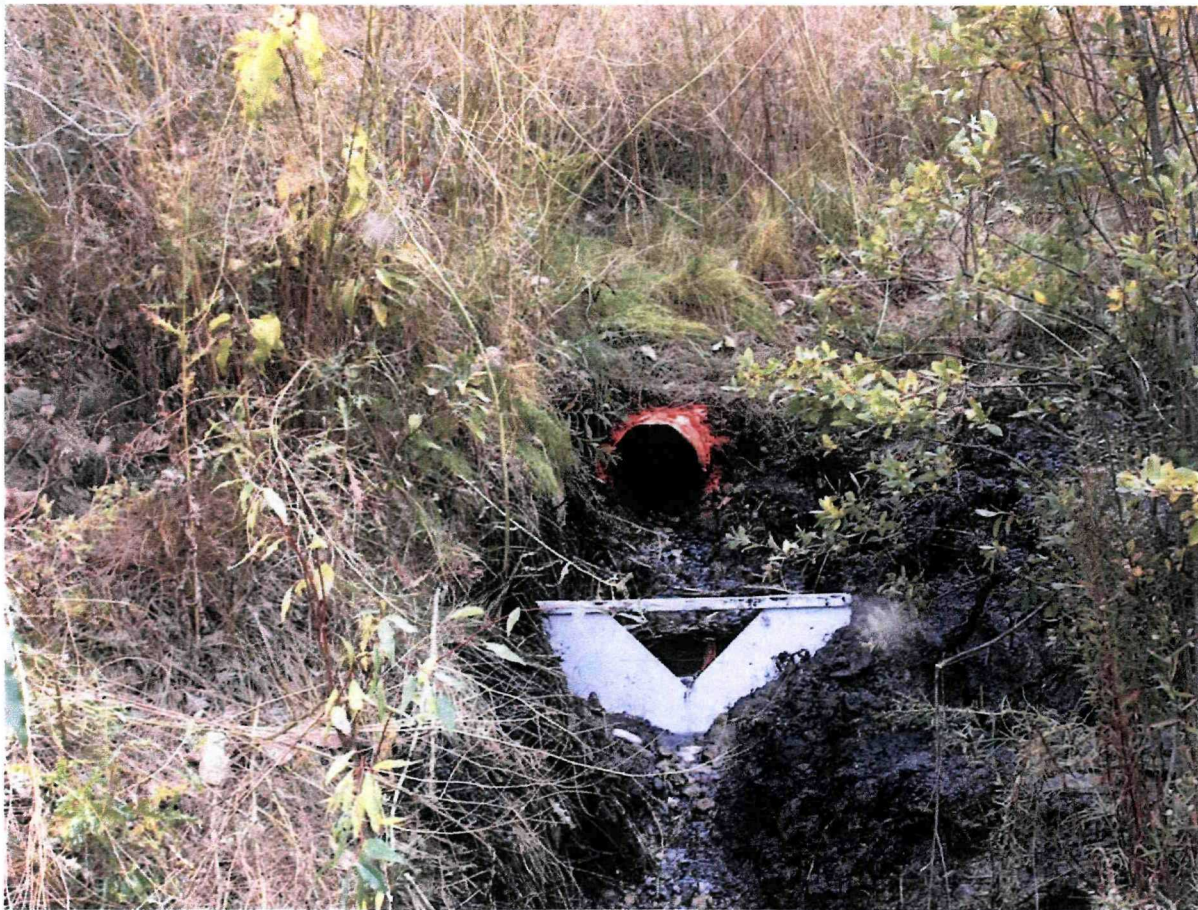
Figure 9: Drain #5 and V-Notch weir below the drain

The V-notch weir read 1.0 inches 2 hours after the weir was set. A reading of 1.0 inches is equal to 2.35 gpm.

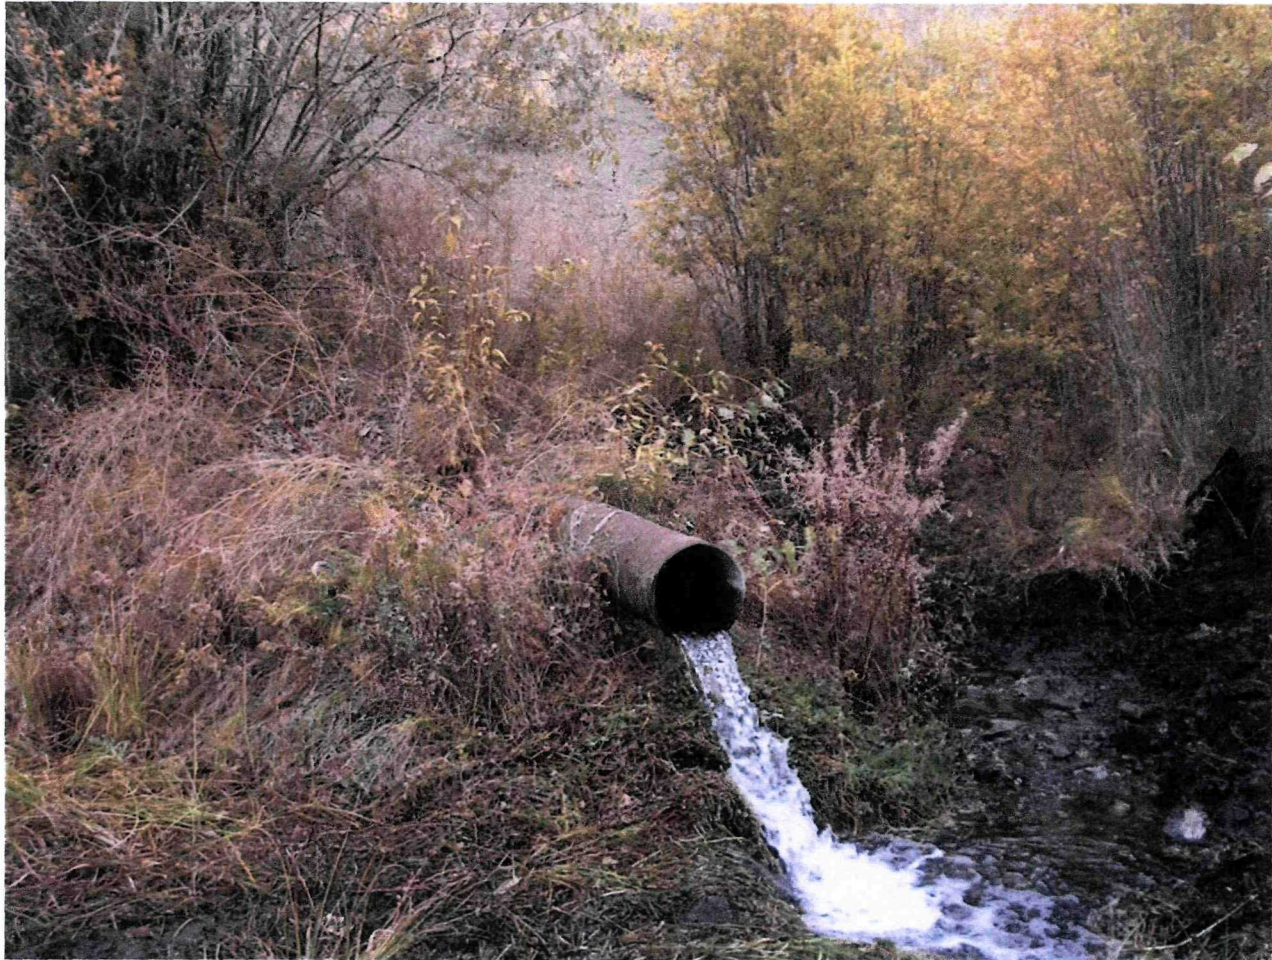
Figure 10: Drain 6 Outside

Drain 6: Drain 6 is a 12 inch steel pipe projecting out from the embankment approximately 3 ft. This drain is located in the center of the embankment and is the highest flowing drain in the toe drain system. The drain flow is monitored by

measuring from the inside top of the pipe to the water surface. A photograph of drain 6 is shown in Figure 10 below. The measurement was 11-5/8 inches below the top inside of the pipe.

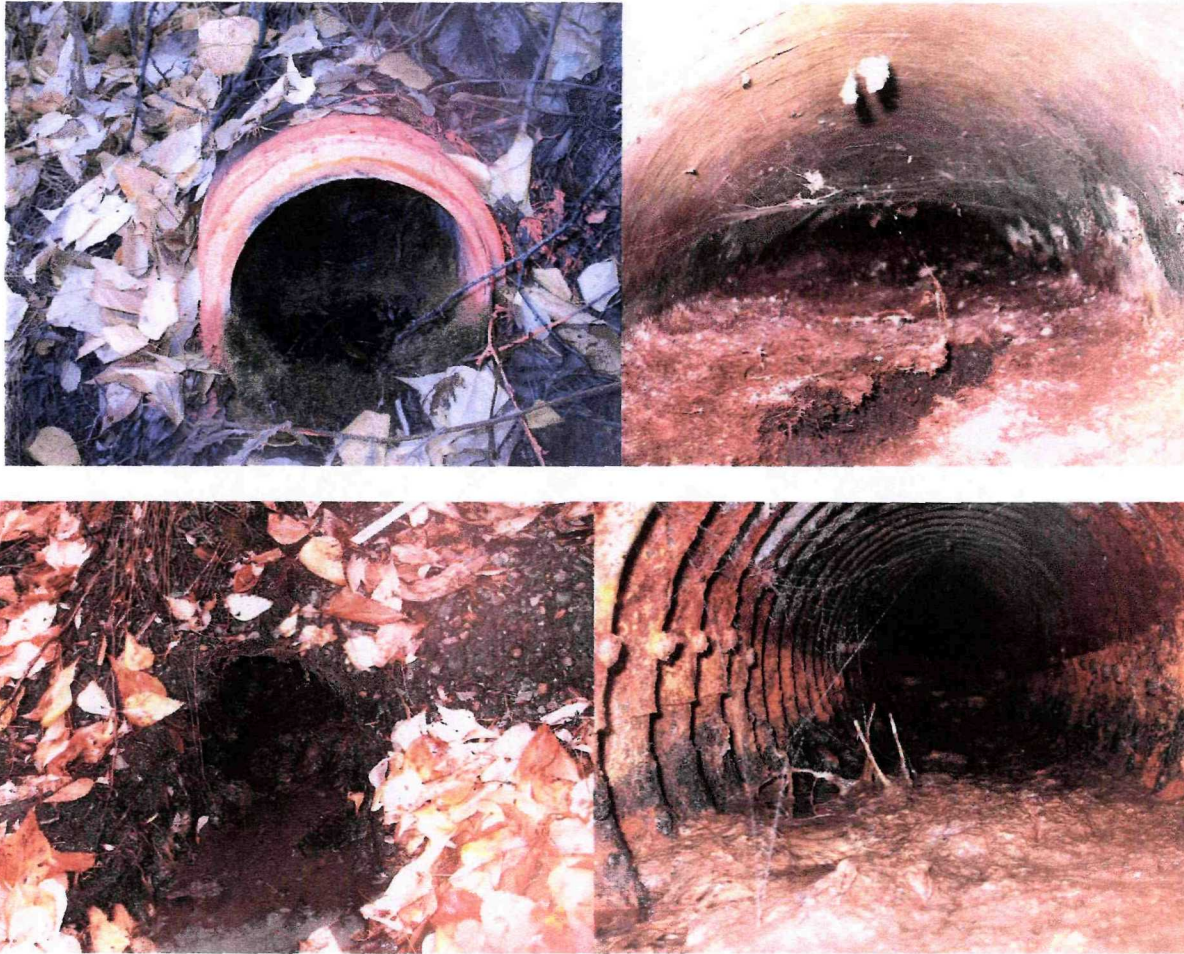
Figure 11: Drains 7 and 8: Outside and inside

Drain 7 and Drain 8: The top drain, Drain 7, is 8-inch concrete pipe near the centerline of the embankment. This drain was originally labeled as drain 6 and is hereinafter labeled as Drain 7. This drain was dry and appeared full to the crown of the pipe with either moss or tree roots. After cleaning brush from Drain 7, a second drain, originally labeled 6a, hereinafter called Drain 8, was located below Drain 7. This drain was discharging water into the channel below the pipe. It is important to note the water that appears on the embankment below Drain 7 and on the ground and all around Drain 8. The area below these drains is very wet and boggy and it appears that neither of these drains is functioning well. Photographs of the outside and inside of each of these drains are shown in Figure 11 below.

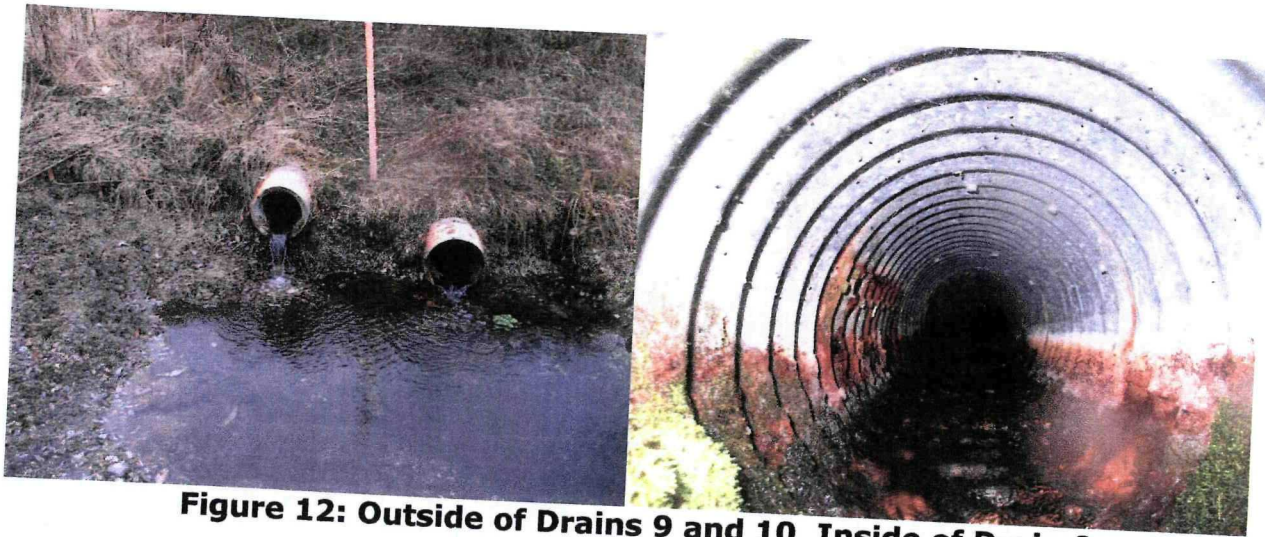
Figure 12: Outside of Drains 9 and 10, Inside of Drain 9

Drain 9 and Drain 10: Drains 9 and 10 were previously labeled as Drain 7 and Drain 8 and are hereinafter labeled as Drain 9 and Drain 10. These drains are located together on the right side of the center of the embankment. Both drains were flowing water. The outside of the drains after cleaning is shown below. There is water flowing in a continuous flow and it is clear. The inside of Drain 9 is open but it is uncertain if there are gravel deposits in the drain. It seems as though there is a considerable amount of rust and corrosion in this pipe as it is an older corrugated metal pipe.

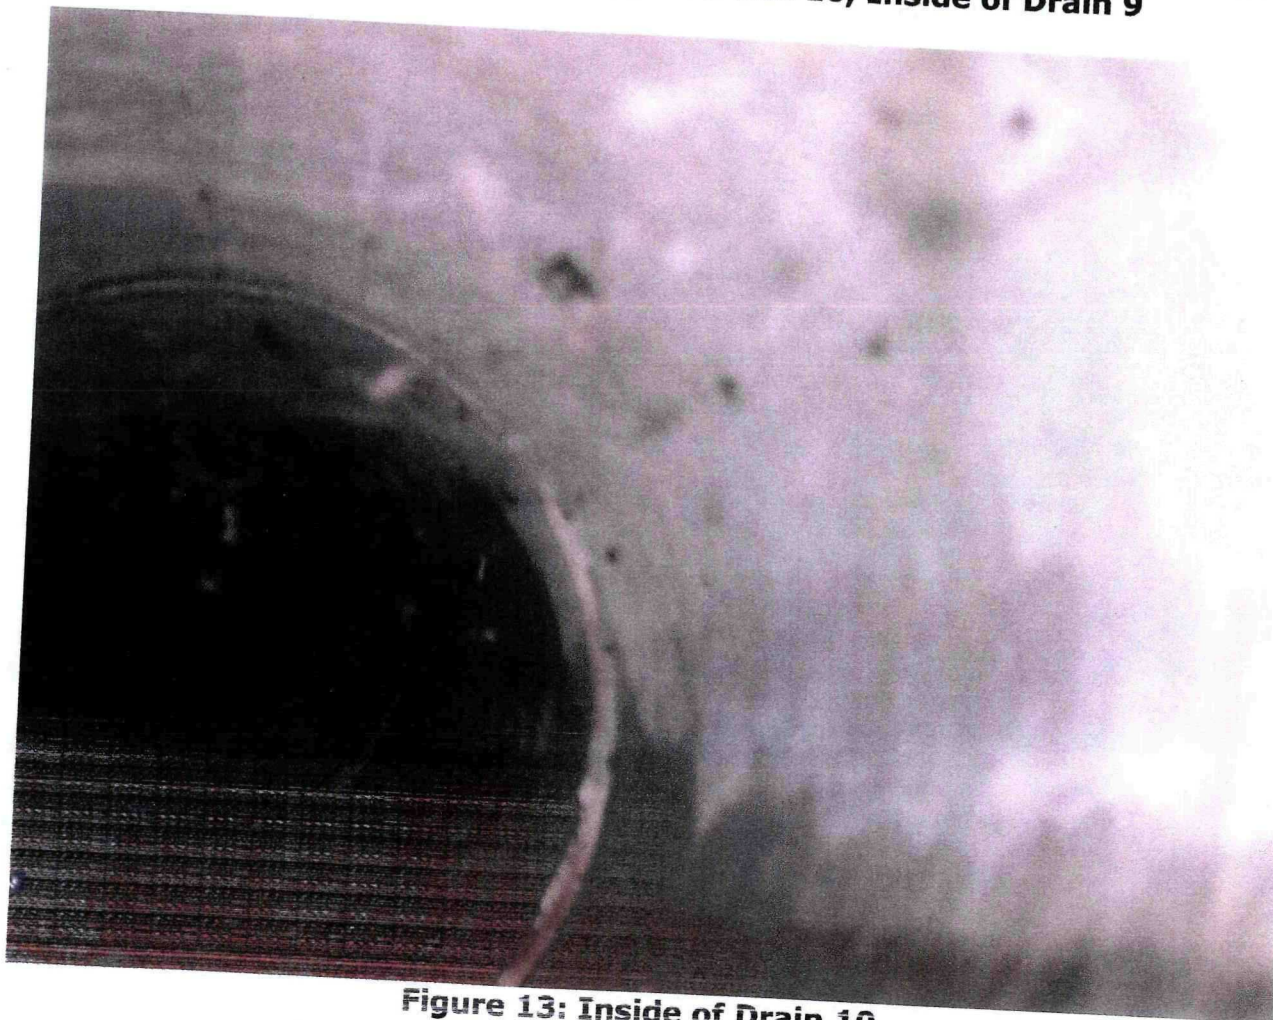
Figure 13: Inside of Drain 10

Drain 10 is a reinforced concrete pipe that is in good condition. There is water flowing in this drain and it is a steady flow and is clear as well. It appears as though there may be a gravel deposit in the upper end of this drain but it is not readily discernable. A photograph of the outside and inside of both of these drains is shown in Figure 12 and Figure 13 below.

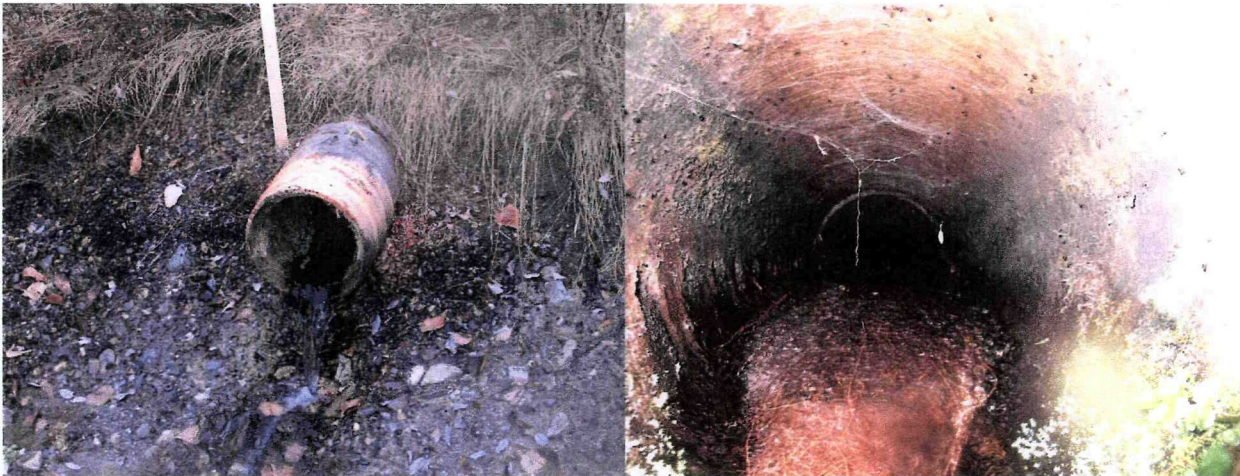
Figure 14: Drain 11 outside and inside

Drain 11: Drain 11 was previously labeled as Drain 9 and is hereinafter labeled as Drain 11. Drain 11 is an 8-inch concrete pipe, flowing water. This drain is approximately 100 ft. to the left of the right groin in the dam. The inside of this drain appears overgrown with roots. The roots can be seen extending from just

inside of the end of the pipe. The outlet of from this and the inside of the drain are shown in Figure 14 below:

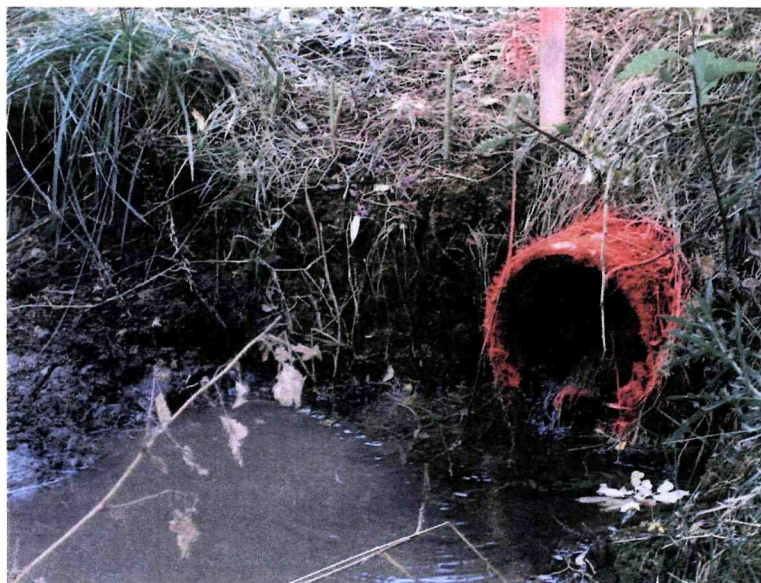
Figure 15: Outside of Drain 12

Drain 12: Drain 12 was previously labeled as Drain 10 and is hereinafter labeled as Drain 12. This drain is the farthest drain to the right of the dam and is located at the toe of the right groin and embankment. This drain is an 8-inch concrete pipe. The inside of this drain is severely over grown with willow roots. A photograph of the outside of the drain is shown in Figure 15 below. It is important to note that the majority of the flow from this drain appears to the right of the drain and flows out of the ground. It is clear that the drainage in this area is mainly on the outside of the drain. A photograph of the flow from the ground surface next to the drain is also shown in Figure 15.

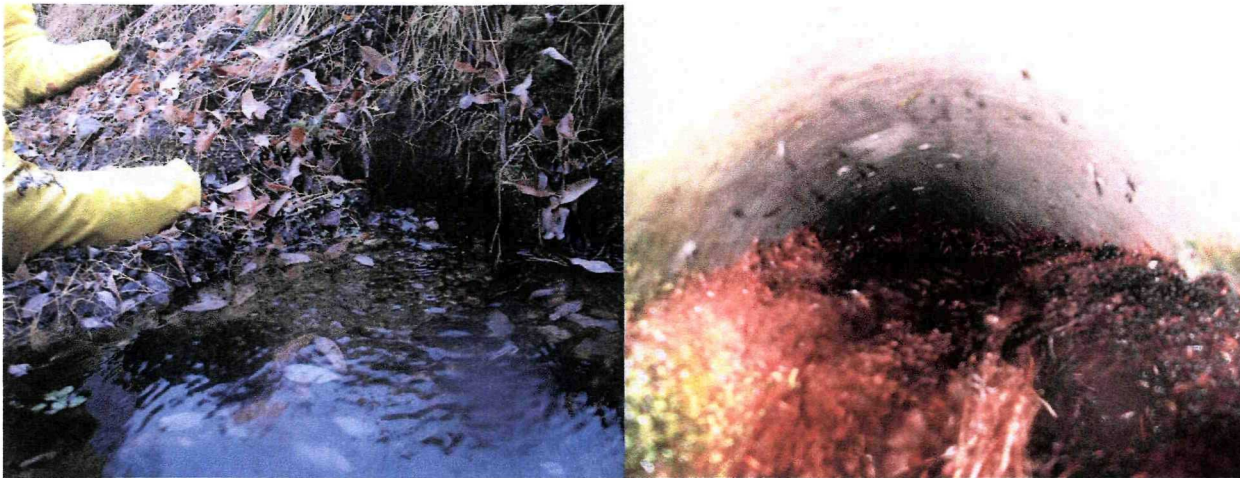
Figure 16: Drain 12 water on the outside and roots on the inside of the drain

There was water still flowing around the root mass and out the pipe end but the majority was around and on the outside of the drain. The water flowing on the outside and the inside of this drain is shown in Figure 16 below.

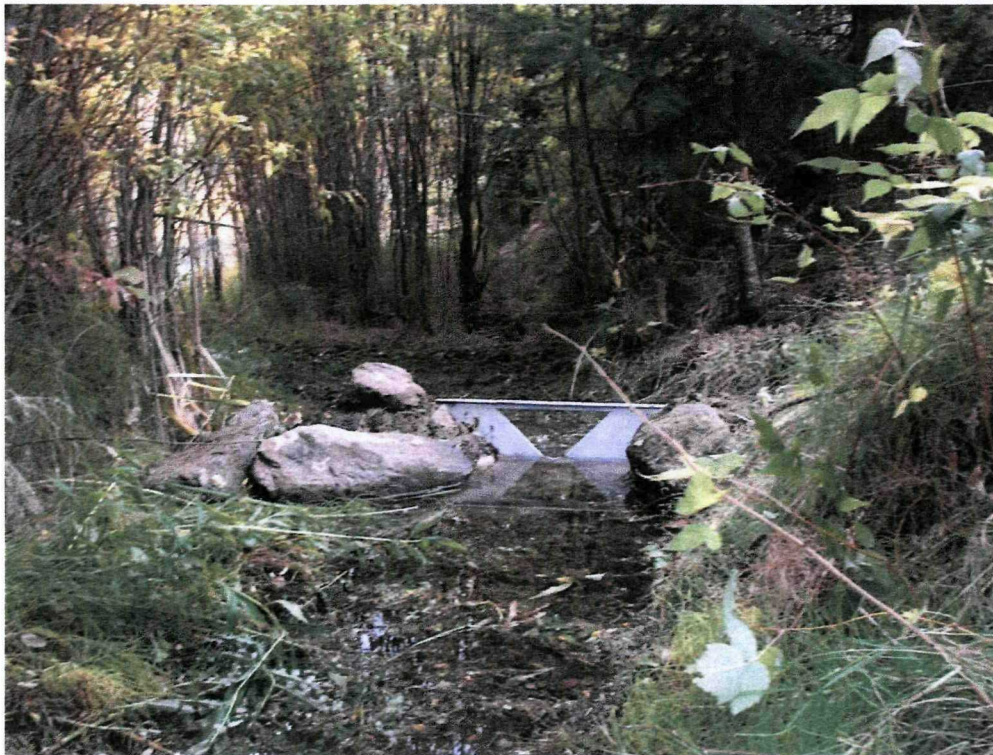
Figure 17: Weir below Drain 12

A V-notch weir was set below Drain 12. The weir read 1-3/4 inches 2 hours after the weir was set. A reading of 1-3/4 inches is 9.34 gpm. A photograph of the weir is shown in Figure 17 below.

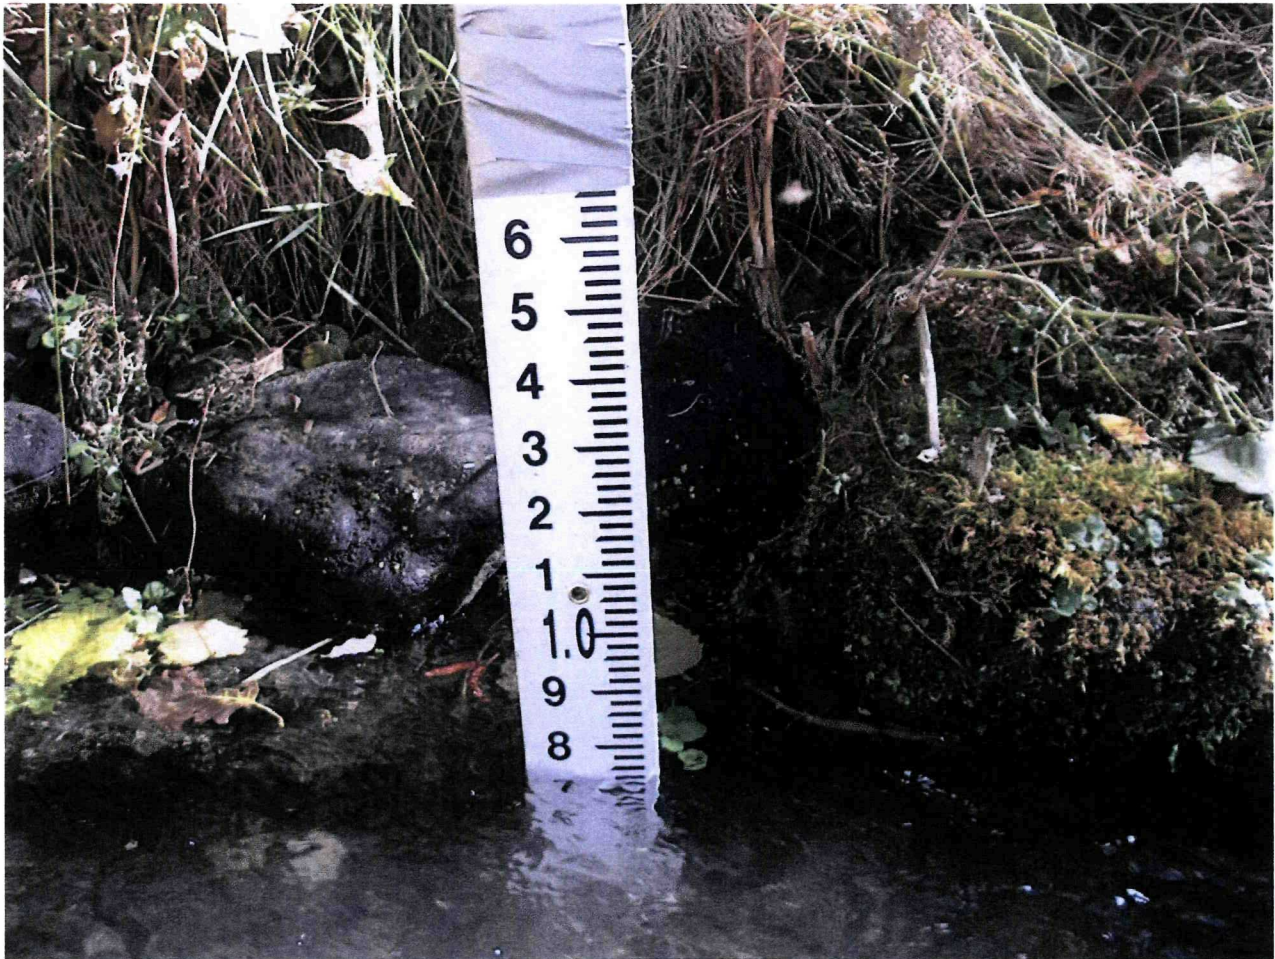
Figure 19: Staff Gauge below all drains

Main Channel: The staff gauge was set in the channel that forms below all of the drains at a location where all of the flow from the drains is collected. A photograph of the staff gauge immediately after it was set and prior to final adjustment is shown in Figure 18 below. The staff gauge was readjusted to be plum and was pushed further down into the stream bed and eventually read 0.785 ft. approximately 3 hours after it was set. The flow was measured using a Marsh McBirney® Flow meter and was found to be 0.289 cfs (130 gpm).
